# HYDROGEN PEROXIDE (H<sub>2</sub>O<sub>2</sub>) INCIDENTS

*(Stories provided by Bobby Berrier and are either oral history or personal knowledge)*

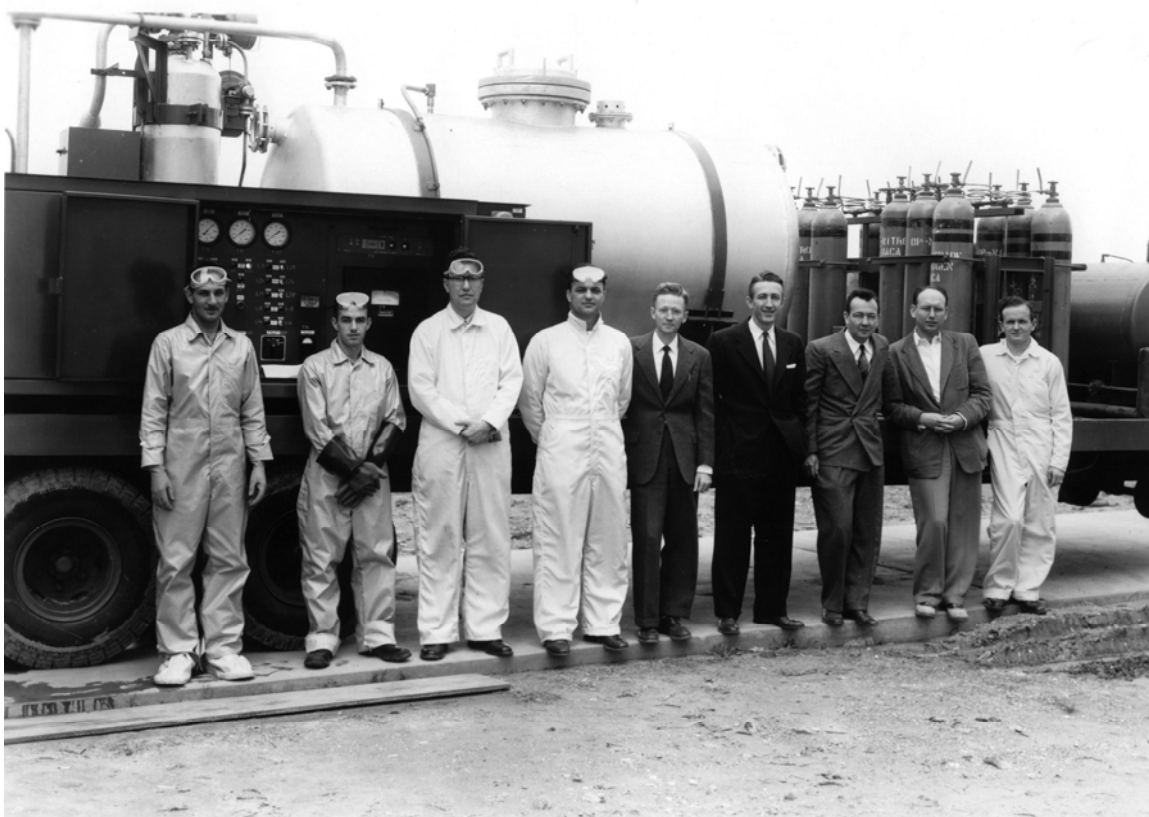
Figure 1.- Hydrogen peroxide storage tank with test crew (white suits) and management (regular coats). L-R: Roth (technician), Bo Montgomery (technician), John Swihart (engineer), Harry Norton (engineer), Jack Runckel (Asst. Branch Head), Julian Maynard (engineer), Blake Corson (Branch Head), Turner (Head of Technicians?); and Ed Lee (engineer).

The hydrogen peroxide was purchased by the railroad tank car load and was stored on an isolated railroad siding. As part of my training, I went on a trip to the tank car to pick up a load for model use but my memory does not let me remember the location of the railroad siding. H<sub>2</sub>O<sub>2</sub> was transferred from the railroad tank car to a truck with a run tank mounted on it (H<sub>2</sub>O<sub>2</sub> trailer) or later to a large tanker truck. A 1955 photograph of the original H<sub>2</sub>O<sub>2</sub> trailer with the test crew and 16'TT management (engineering and technicians) is shown in Figure 1.

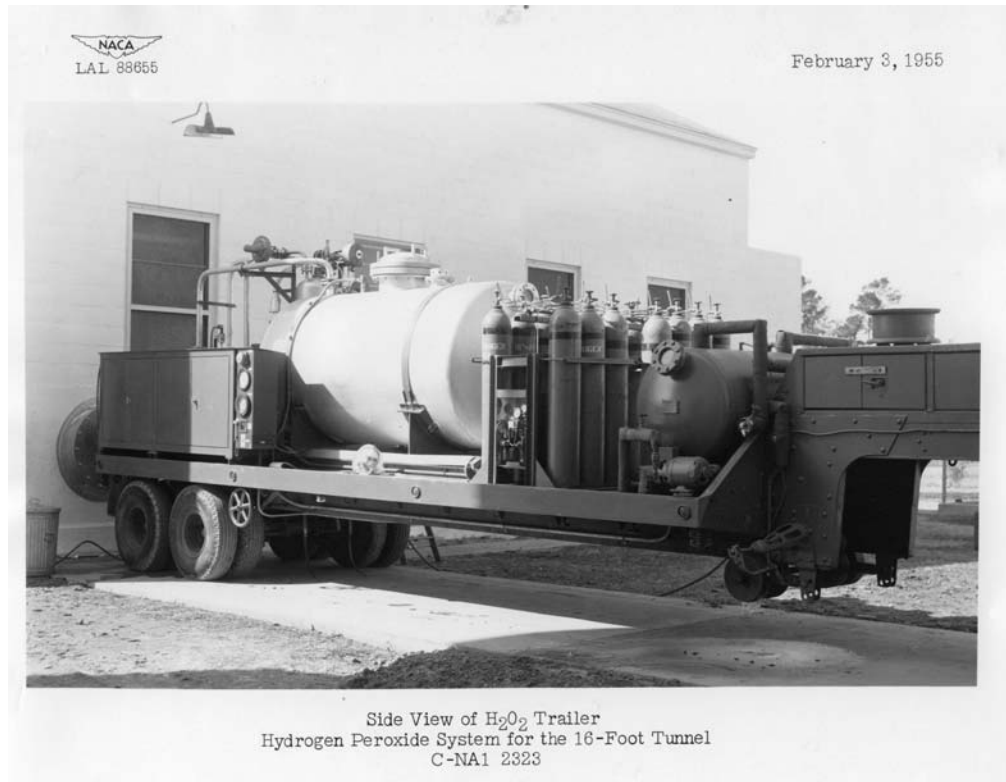
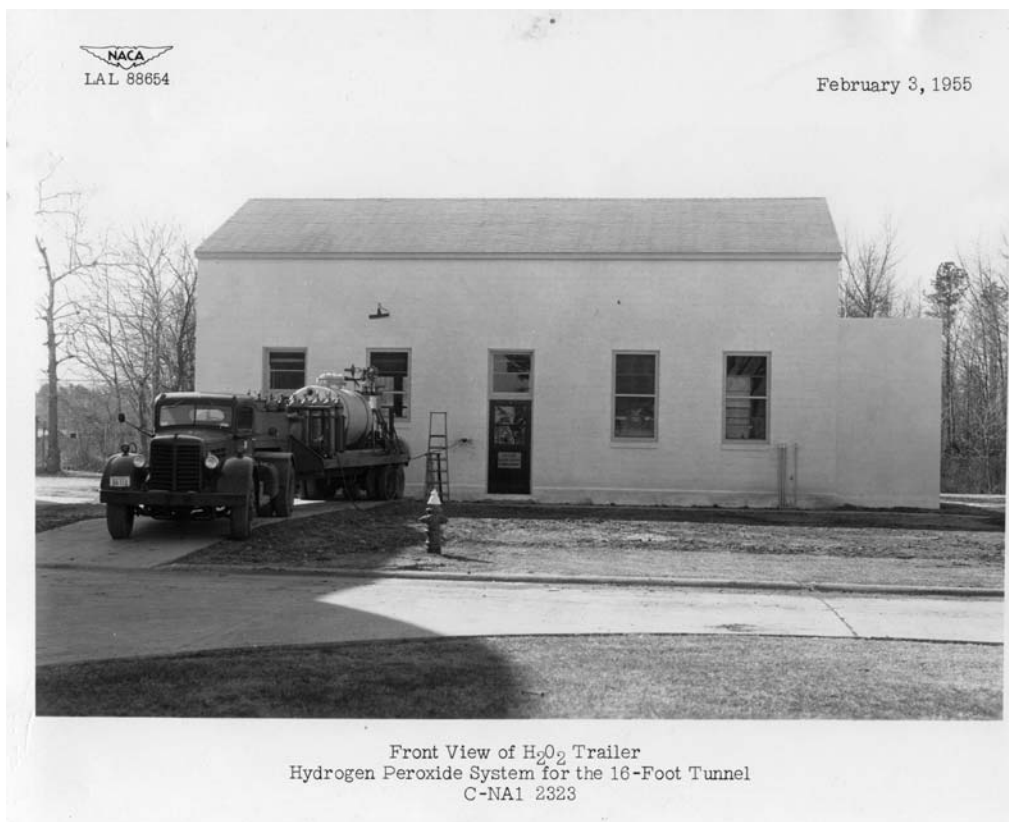
Figures 2 and 3 show the  $\text{H}_2\text{O}_2$  trailer connected to building 1234 (JETF) where  $\text{H}_2\text{O}_2$  models were checked out before being installed in the 16'TT. The models were mounded in a trench that could be quickly flooded in case of a  $\text{H}_2\text{O}_2$  leak.

Figure 2.-  $H_2O_2$  trailer in front of building 1234.

Figure 3.-  $H_2O_2$  trailer in front of building 1234.

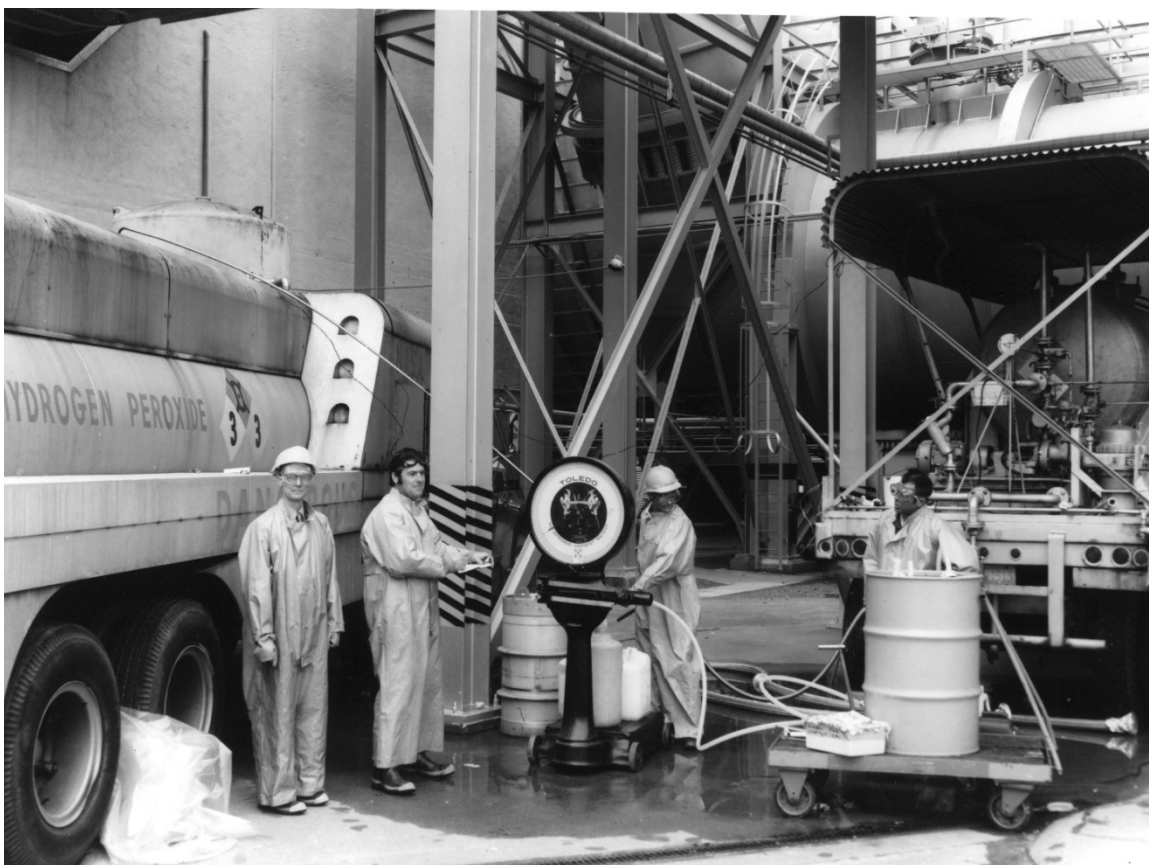
The large tanker truck that was used later for  $\text{H}_2\text{O}_2$  transfer from the railroad tank car is shown on the left side of Figure 4. In the photograph, it appears that a  $\text{H}_2\text{O}_2$  transfer is being made from the tanker truck to the smaller run trailer (with sun shade over top) that is connected through piping to the model installed in the test section. This operation is being conducted underneath the 16-Foot Transonic Tunnel (test section is located above and to the left of the tanker truck).

Figure 4.- Tanker truck and  $\text{H}_2\text{O}_2$  run trailer underneath 16-Foot Transonic Tunnel. L-R: Bill Compton (engineer), Mike Taylor (future head of 16' TT technicians), Ben Adderholdt (technician), and Keith Lupton (technician behind barrel).

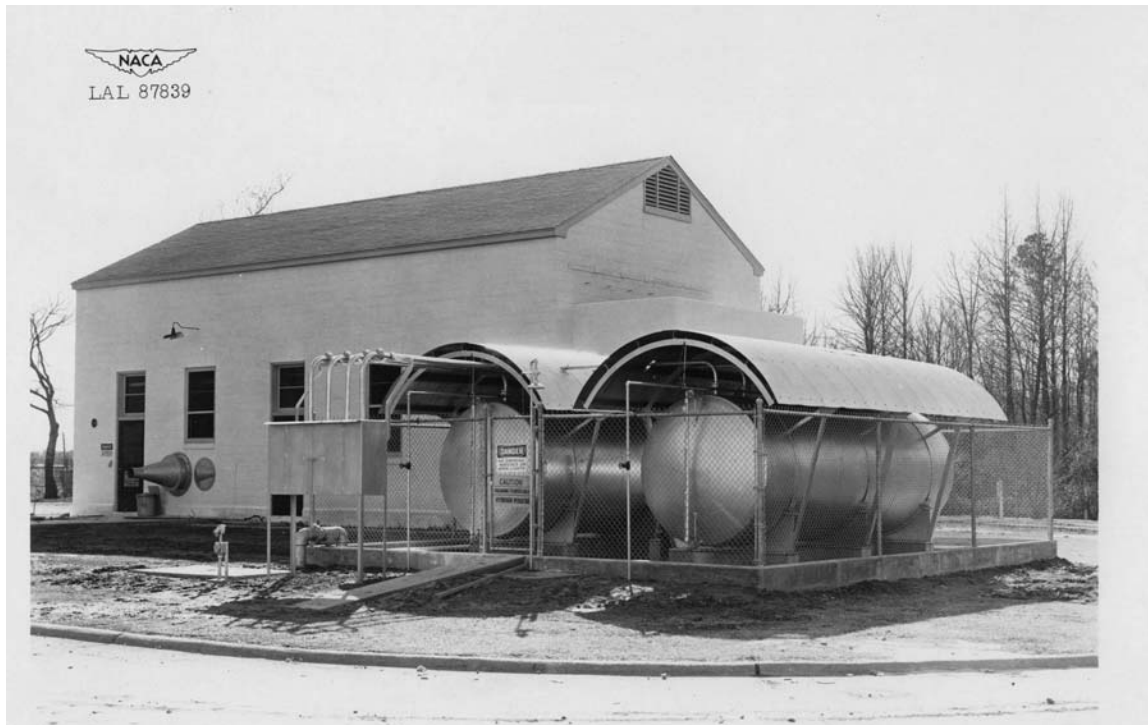
To eliminate the need for frequent trips to a railroad tank car to pick up hydrogen peroxide, two aluminum tanks were constructed near building 1234 (JETF) to store  $\text{H}_2\text{O}_2$  locally. These tanks are shown in Figure 5. Note the raised concrete perimeter around the tanks to contain any spills or leaks; a drain was located within the perimeter. As previously mentioned,  $\text{H}_2\text{O}_2$  is unstable if stored in improper containers or comes in contact with even a small amount of contaminate. In this case, a slow chemical reaction is initiated with an attendant release of heat that accelerates the chemical reaction. To detect a chemical reaction starting in the  $\text{H}_2\text{O}_2$  tanks, thermocouples were installed to

measure the temperature of the tanks; the thermocouples were connected to alarms in the heating (steam) plant that was manned 24/7. If one of these temperature alarms was triggered during a 16' TT off-shift or on a weekend, the heating plant had a call list of 16' TT engineers that lived close to the field. Engineers on the list were called until one was found that could come out to the field to check the  $\text{H}_2\text{O}_2$  tanks. Engineers liked to be on this list since if they were called to come out to check the tanks (less than a five minute procedure), they would earn 2 hours of compensatory leave. Since I lived in Poquoson for a while, I was happy to be on the list. It took me less than 15 minutes to drive to the field. The procedure to check the tanks was to walk up to the tanks and put your hand on them. If they did not feel warm, you reset the alarm and went home. If they felt warm or hot, you opened valves to dump the hydrogen peroxide down the drain (I can't remember now, but some water valves may have also been opened to dilute the hydrogen peroxide). **Do you think the safety office would pitch a hissy fit today?** Either way, I earned 2 hours leave for about 35 minutes of work including travel time.

Figure 5.-  $\text{H}_2\text{O}_2$  storage tanks in front of building 1234.

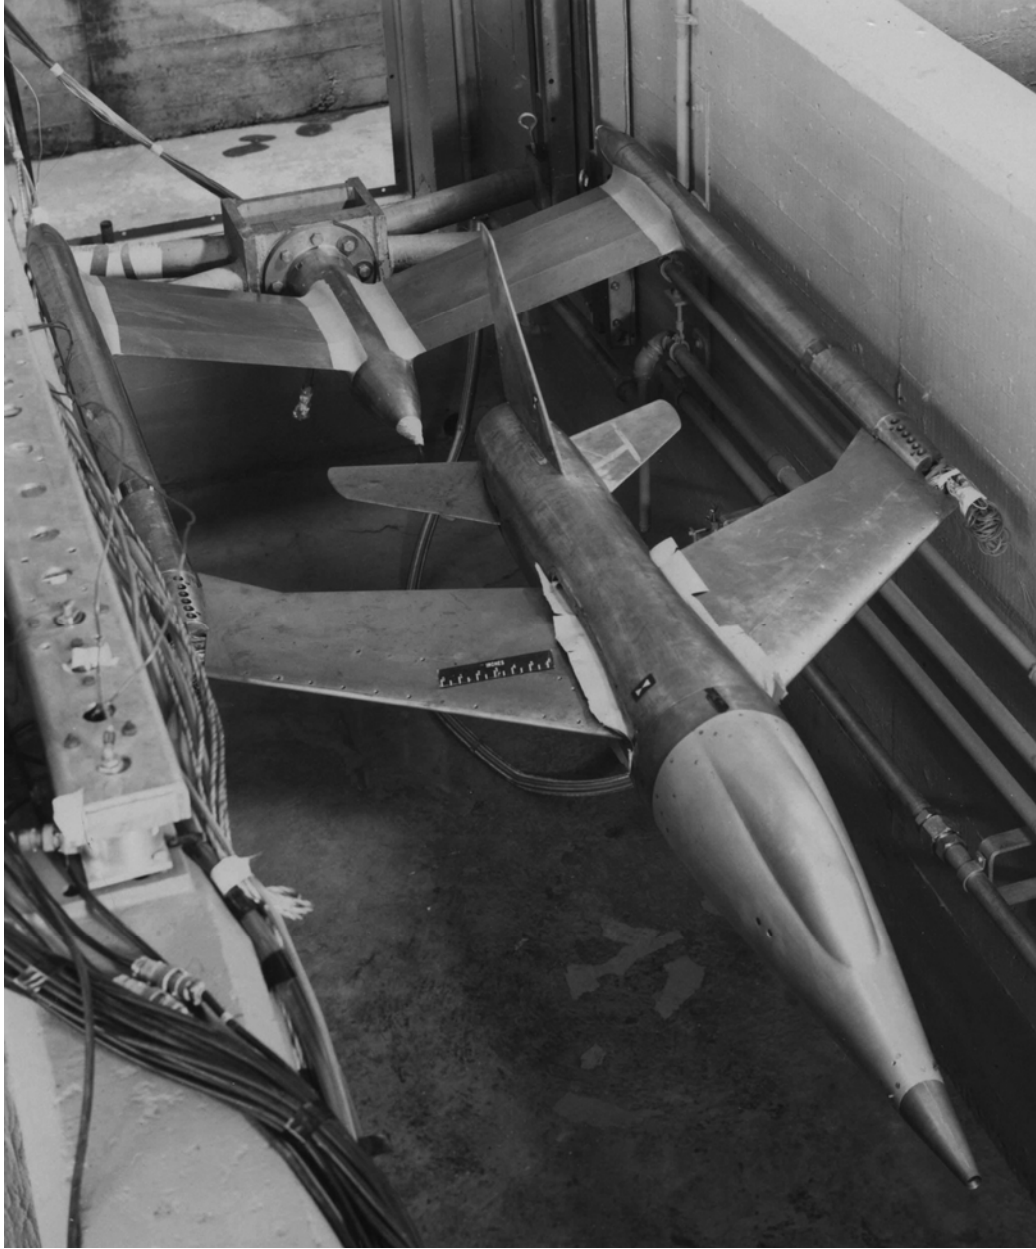
As mentioned previously, hydrogen peroxide powered models were usually checked out in the JETF (building 1234) before being installed in the 16' TT for testing. A trench in the JETF, which was equipped with high-flow pumps that could flood the trench with water in case of a  $\text{H}_2\text{O}_2$  leak, was used for this purpose. Figure 6 shows a photograph of the Grumman F-11F-1 Tiger  $\text{H}_2\text{O}_2$  propulsion model installed in the trench during checkout.

Figure 6.- Grumman F-11F-1  $\text{H}_2\text{O}_2$  propulsion model installed in JETF trench.

catalyst pack). When this occurred, the hydrogen peroxide would not completely decompose, a condition known as “running wet”, and a cloud of hydrogen peroxide would be expelled from the nozzle exit. During model checkout in the trench of building 1234, a door would be opened behind the model (see Figure 6) and the nozzle exhaust would be directed outside of building 1234. During this process, if the model were “running wet”, a large cloud of atomized hydrogen peroxide would be directed outside. At this time, the wood model shop was located across the street from building 1234 (in what is now, the cafeteria parking lot) and since the shop was not air conditioned, would have large roll doors open during the summer. If the wind was in the right (or should I say wrong) direction, it was not unusual for the 16’TT Branch Head (Blake Corson) to receive a call from the wood shop asking us to stop running in building 1234 because a cloud of hydrogen peroxide had floated across the road and through the open roll doors resulting in everyone’s eyes watering.

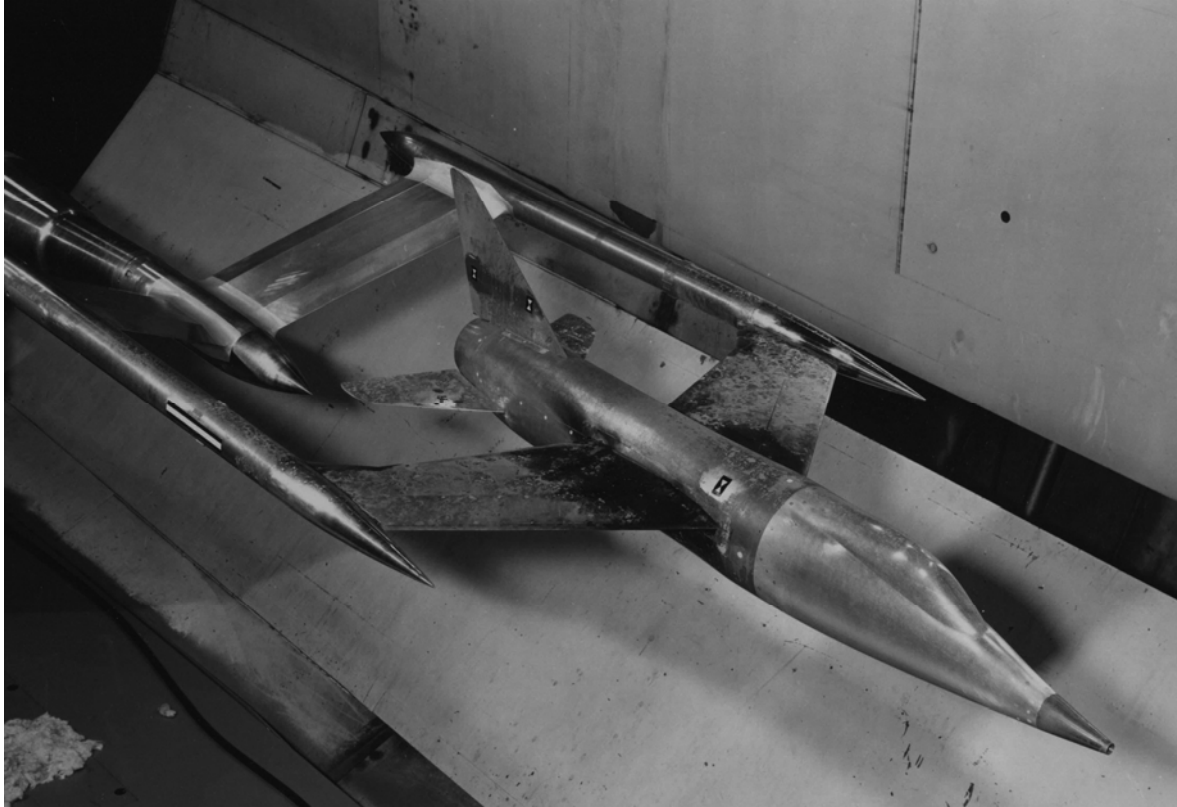
A photograph of the Grumman F-11F-1 model installed in the 16-Foot Transonic Tunnel after checkout is shown in Figure 7.

Figure 7.- Grumman F-11F-1  $\text{H}_2\text{O}_2$  propulsion model installed in 16'TT.

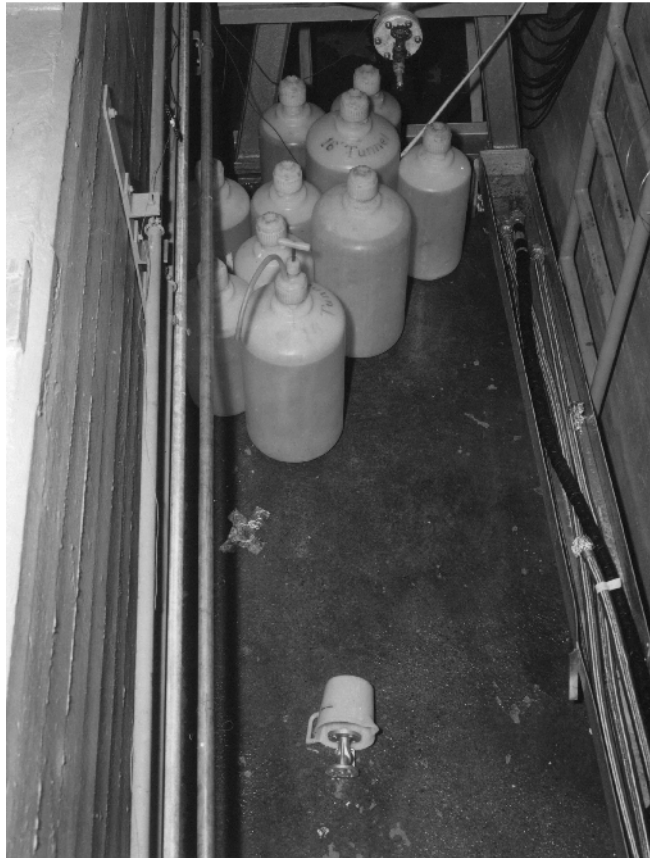
As mentioned previously, components that were to be used with  $\text{H}_2\text{O}_2$  were checked for compatibility with the fuel before being used. In addition to model checkout, the trench in building 1234 (described in the previous story) was used for this purpose as well. Small parts (bolts, run valves, etc) were placed in buckets of  $\text{H}_2\text{O}_2$  and left in the trench for a period of time. The bucket would be checked later to see if a chemical reaction had started. If no chemical reaction was detected, the part was deemed satisfactory for use on the model. Figure 9 presents a photograph of the trench in building 1234 with containers of hydrogen peroxide used for these compatibility checks.

Figure 9.- Photograph of trench in building 1234. Note jugs of  $\text{H}_2\text{O}_2$ .

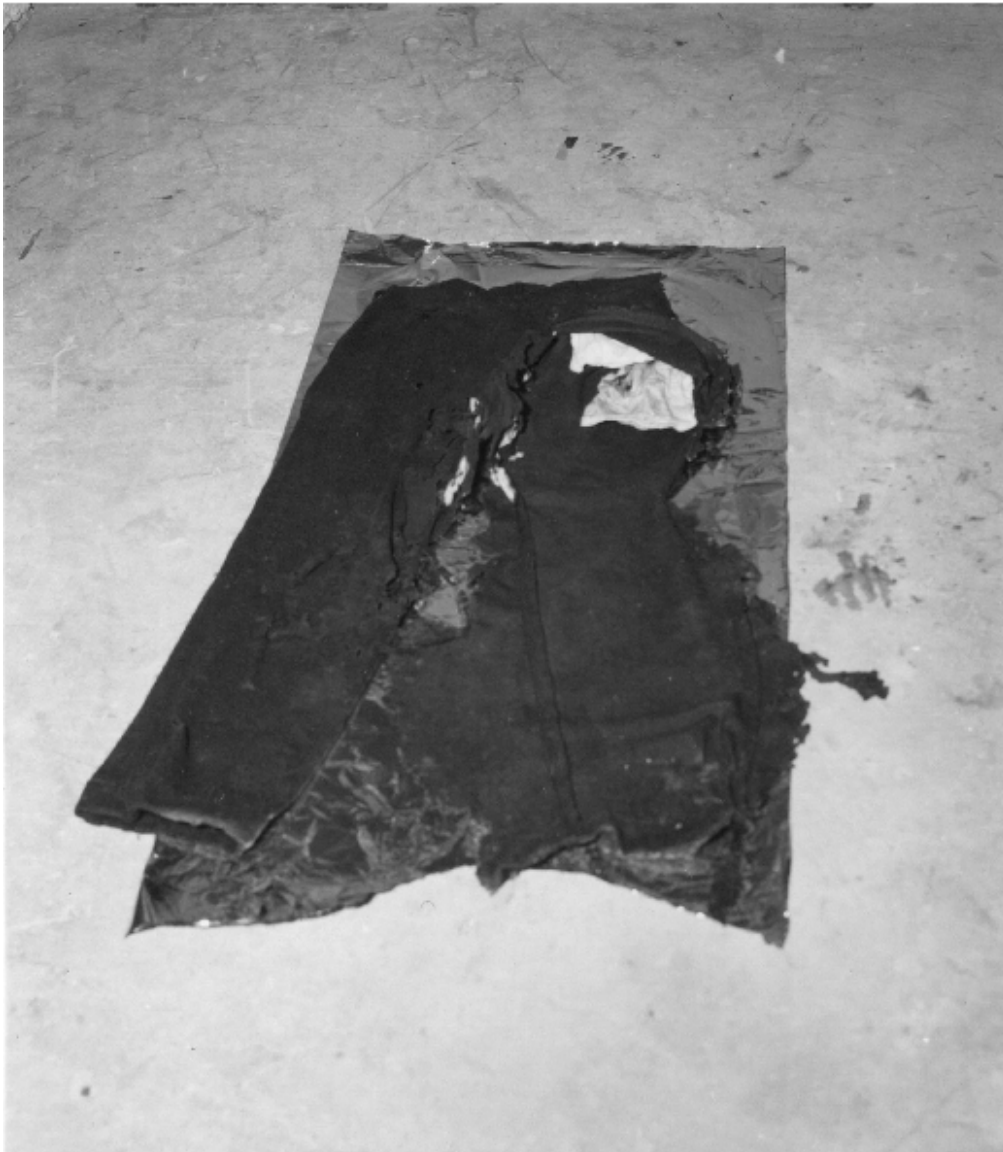
One day in 1959, a young engineer named Ed Lee (see Figure 1) was checking the compatibility of a model component in a bucket of  $\text{H}_2\text{O}_2$  down. He started climbing down into the trench using a ladder mounted on the trench sidewall (see Figure 9). Unfortunately, at the bottom of the ladder, he stepped in or on the bucket of  $\text{H}_2\text{O}_2$  with the model component in it (it can be seen turned over in Figure 9). Before he could climb out of the trench and get to one of the wall-mounted showers, his pants were on fire! A post-incident photograph of his pants is shown in Figure 10. Ed was apparently not harmed to a great extent as he was still at 16'TT when I came to work in 1963.

Figure 10.- Ed Lee's pants after stepping into a bucket of hydrogen peroxide.
